## **Functional and Structural Evaluation of a Link Road subjected to frequent deteriorations**

### **Abstract**

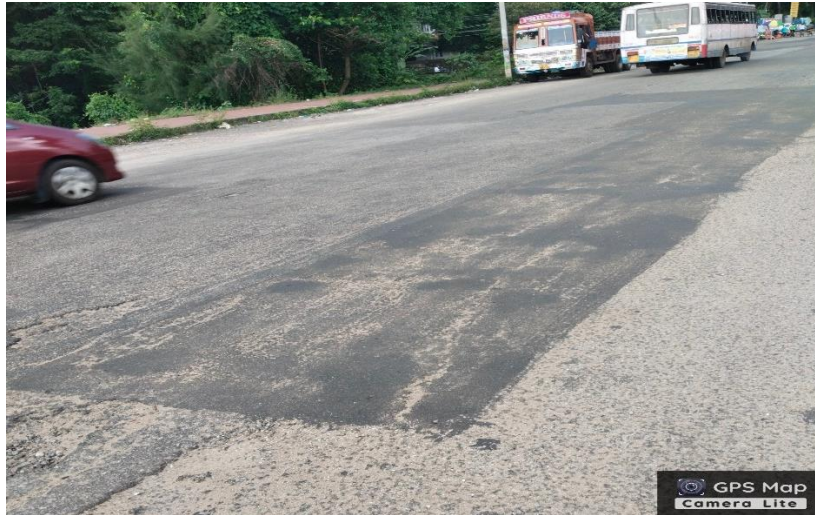
**Figure 1: Road section with patch works**

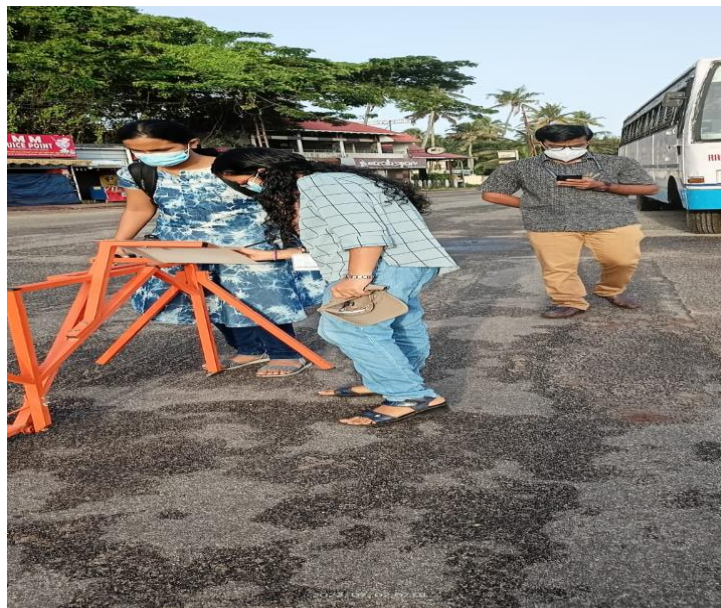
Figure 4: Measurement using MERLIN
