# **The Effect of Ground Water Level on the Stability of Retaining Walls and Land Movement on the Lampa-Timbong Road Section, Banggai District, Banggai Laut Regency**

The Lampa–Timbong road section in Banggai Laut Regency has experienced ground movement and retaining wall instability due to fluctuations in the groundwater table during the rainy season. Rainwater infiltration increases pore water pressure and decreases effective stress, thereby reducing soil shear strength and triggering deformation or potential collapse. This study employed the Finite Element Method (FEM) using PLAXIS 2D to evaluate the effects of groundwater level variations on the stability and deformation of a cantilever retaining wall. The numerical modeling simulated groundwater levels ranging from the initial depth of  $-0.35$  m up to  $+4.5$  m, influenced by rainfall infiltration with an intensity of  $0.01889$  m/day. The soil, classified as MH (Inorganic Silt of High Plasticity) according to USCS and A-4 according to AASHTO, exhibits high plasticity, low permeability, and low bearing capacity. The analysis indicates that groundwater level rise significantly affects wall stability. Under the initial cond

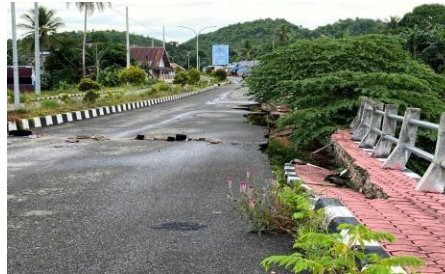
**Figure 1.** Damage Conditions at the Study Location

The road currently exhibits severe damage, as evidenced by the subsidence of the pavement. This phenomenon indicates soil instability that requires further investigation. In this case, the accumulation of subsurface water likely contributes to increased lateral pressure on the retaining wall, triggering significant structural deformation. The impacts are not only evident in physical structural damage, such as cracks and displacement in the retaining wall, but also in the deterioration of the road surface.
