Effect of LVOF Sprayed Coating in Oxidation & Hot Corrosion Performance of Boiler Steel SA-192 at Different Temperatures.

ABSTRACT : Oxidation and hot corrosion is the major degradation mechanism of failure of boiler and gas turbine components. These failures occur because of the usage of wide range of fuels such as coal, oil at increased temperatures. To obviate these problems, in current investigation $Al_2O_3+40\%TiO_2$ powder has been deposited on Boiler Steel SA-192 by LVOF (Low velocity oxy fuel process). The oxidation and hot corrosion performances of $Al_2O_3+40\%TiO_2$ coated as well as bare Boiler Steel SA-192 has been evaluated in air and with aggressive environment $Na_2SO_4+60\%V_2O_5$ under cyclic conditions at an elevated temperatures of $850^{\circ}C$ & $950^{\circ}C$. The kinetics of the corrosion is approximated by weight change measurements made after each cycle for total duration of 50 cycles. Each cycle consists of keeping the samples for 1 hour duration in Kanthol wire tube furnace at $850^{\circ}C$ and $950^{\circ}C$ followed by 20 minute cooling in ambient air. Weight change data has been taken after each cycle by digital electronic balance machine with an

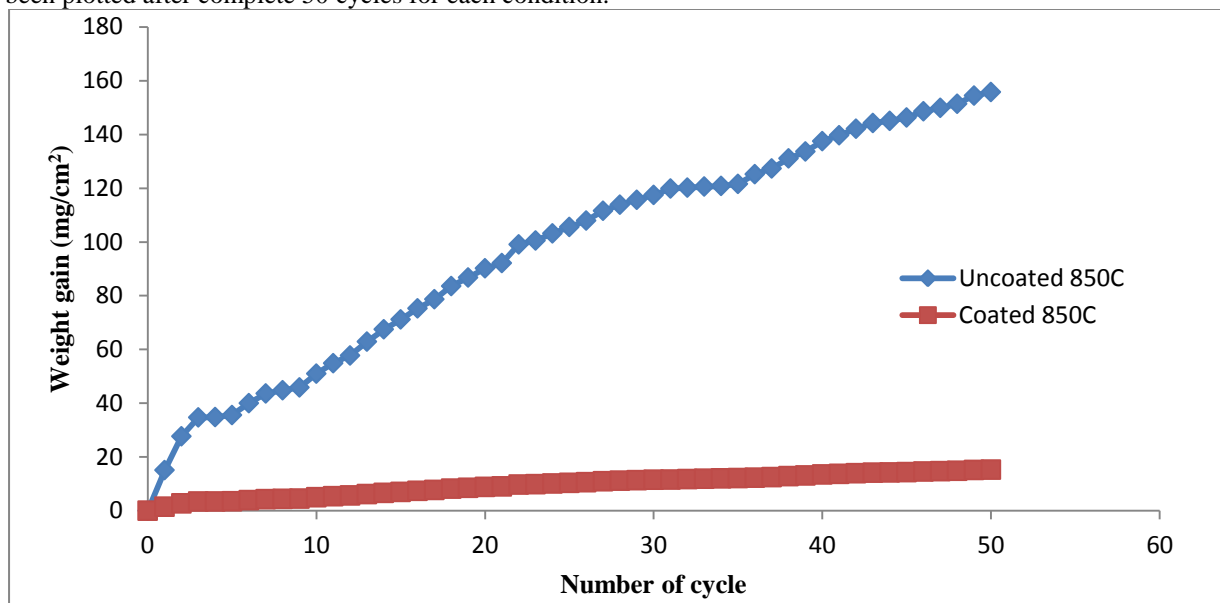
Fig: 3.1 Oxidation performance of Coated and Uncoated Boiler Steel SA-192 at $850^\circ C$.

Oxidation and Hot Corrosion testing has been done and for each cycle weight change has been measured. This weight change is in milligram and for result we divide it by surface area of used superalloy for testing. After this plot a graph between Number of cycle and Weight change (mg/cm^2). Following graph has been plotted after complete 50 cycles for each condition.

Uncoated Boiler Steel SA-192 Weight gain at 850°C is 155.67 mg/cm² and Coated Boiler Steel SA-192 is 15.27 mg/cm² up to 50 cycles. Uncoated Boiler Steel SA-192 Weight gain at 950°C is 274.29 mg/cm² and Coated Boiler Steel SA-192 is 18.104 mg/cm² up to 50 cycles.

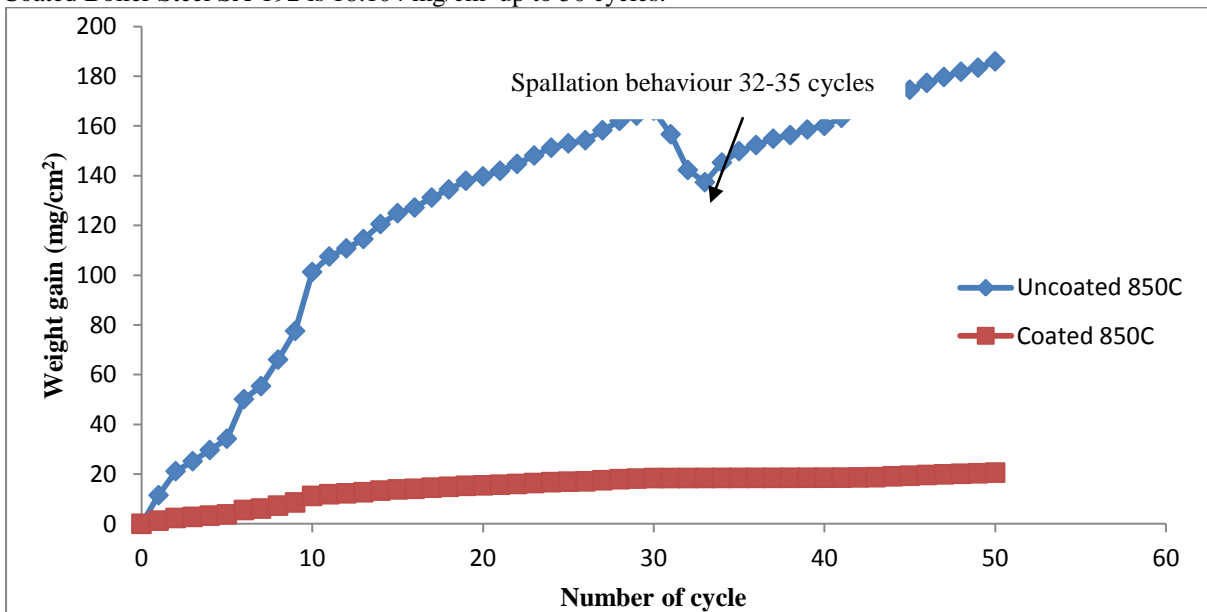
Fig: 3.3 Hot Corrosion performance of Coated and Uncoated Boiler Steel SA-192 at 850°C.

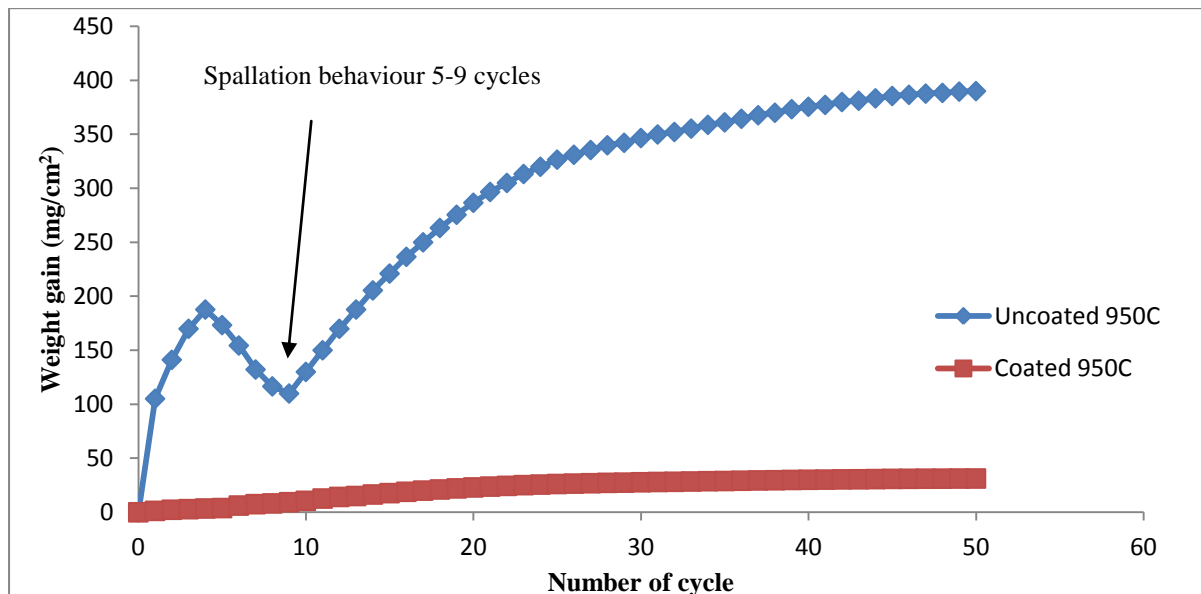
Fig: 3.4 Hot Corrosion performance of Coated and Uncoated Boiler Steel SA-192 at 950⁰C.
