6 FEBRUARY 2023 KAHRAMANMARAŞ (PAZARCIK, Mw:7.7 and ELBİSTAN, Mw:7.6) and SAMANDAĞ (Mw:6.3) EARTHQUAKES, SE TÜRKİYE

Abstract

2.4. Surface Ruptures and Pulse Distributions of the February 6 Earthquakes

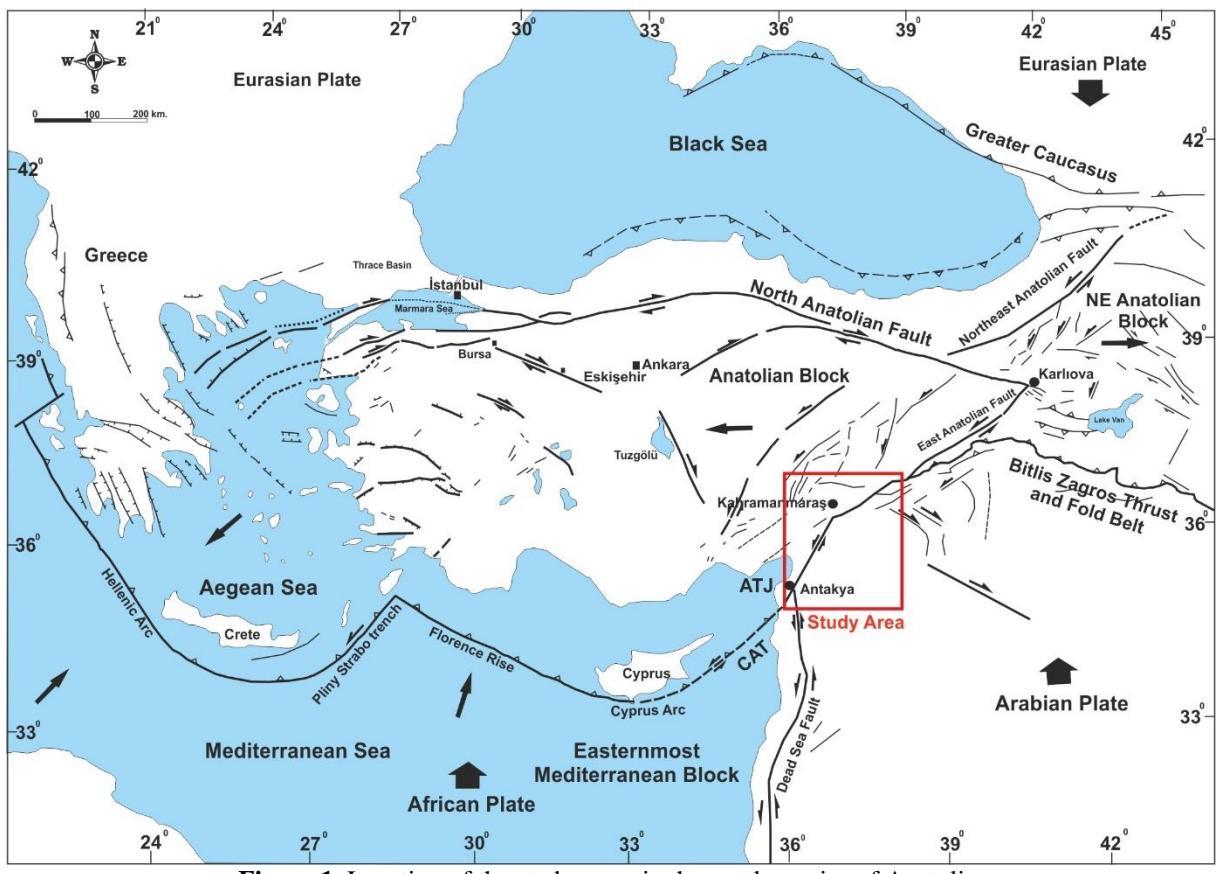
Figure 1. Location of the study areas in the geodynamics of Anatolia

In this study, the significant displacements caused by the February 6 Kahramanmaraş earthquakes were recorded by following the surface ruptures on the earth's surface. It was also tried to reveal which fault segments were affected by these earthquakes (Figure 1).

Geologically, the Anatolian Block (Anatolian micro plate) is located within the Alpine-Himalayan Mountain Belt (continental-continental collision front). The part of this collision front within Anatolia is bounded by the Lavrasian Plate to the north and the African and Arabian Plates to the south. For the last ten million years, the Anatolian Micro Plate has been caught between the southward movement of the Lavrasian Plate and the northward movement of the African and Arabian Plates that broke away from it. The Anatolian Block has been trying to escape this compression by moving westward. About five million years ago, the right-lateral strike-slip North Anatolian Fault bounding Anatolia from the north and the left-lateral strike-slip East Anatolian Fault bounding from the south were formed (Şengör and Yılmaz, 1981). These two faults have been behaving in a similar manner and producing earthquakes for the last few million years. Thus, the Anatolian Block has been sliding westward from the eastern continental collision front (Figure 1).

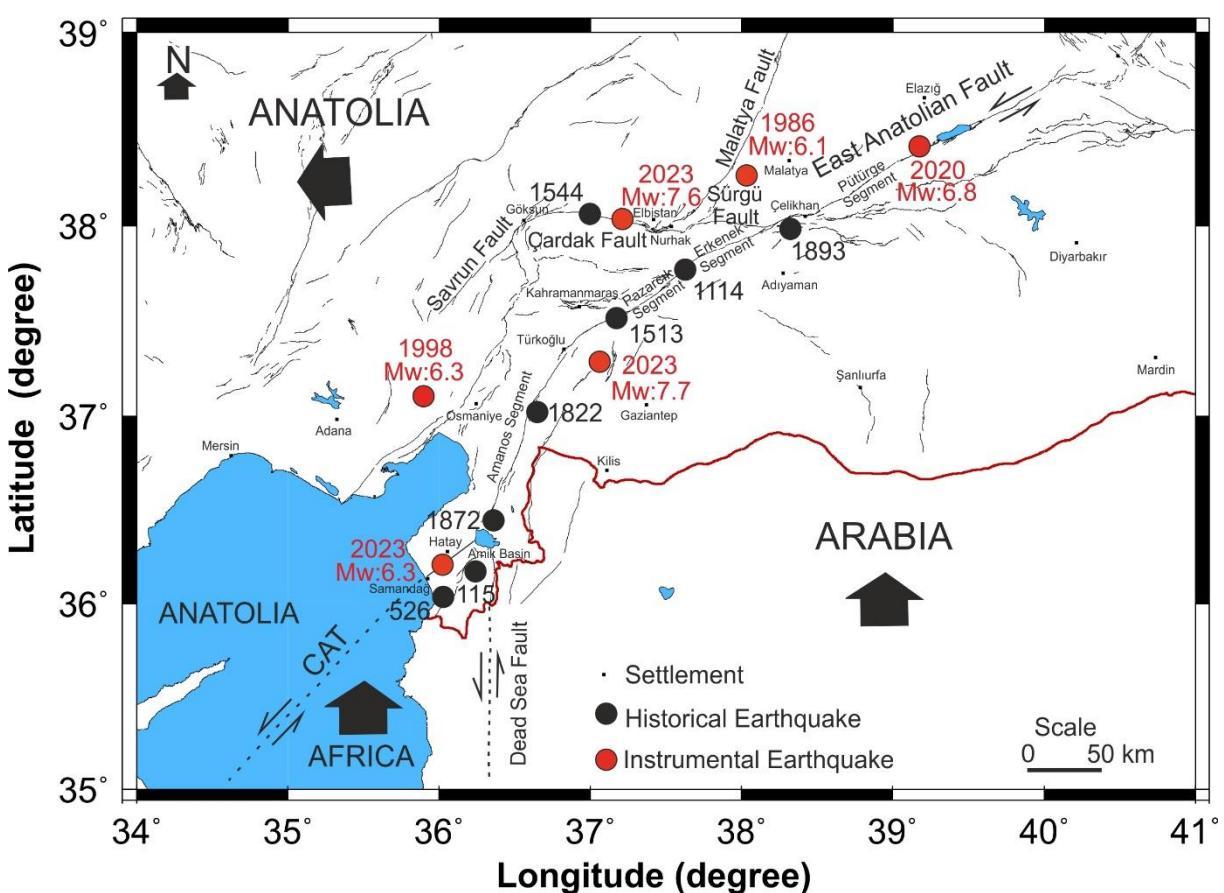
Figure 2. Historical and instrumental earthquakes in the study area (Revised from Över et al., 2023).

The main fault in the earthquake zone is the Eastern Anatolia Fault and its segments (Figure 2). These segments start from Karliova in the east and extend to Antakya in the south. These are Pütürge, Erkenek, Sürgü-Çardak, Pazarcık, Amanos and Antakya (Samandağ) segments or faults (Figure 2).

The region has experienced major earthquakes in historical and instrumental periods (Figure 2). Two large earthquakes were recorded on the Amanos segment in 1822 and 1872. Similar large earthquakes were recorded on Pazarcık and Erkenek segments in 1114, 1513 and 1893. The last major earthquake was recorded in 1544 on the Çardak Fault, which is a splay fault and separated from the East Anatolian Fault. Thus, it is seen that there has been no earthquake on the Eastern Anatolia Fault, especially on the Pazarcık and Çardak faults for 500 years, this is a serious seismic gap and the two major earthquakes in 2023 occurred on these two faults. Although there have been earthquakes in the last century in Adana in 1998 and Elazığ in 2020, it is known that the Eastern Anatolia Fault has been silent for a very long time. Although 150-200 years have passed since the last two earthquakes on the Amanos segment, this fault was also broken in the first earthquake on February 6, 2023.

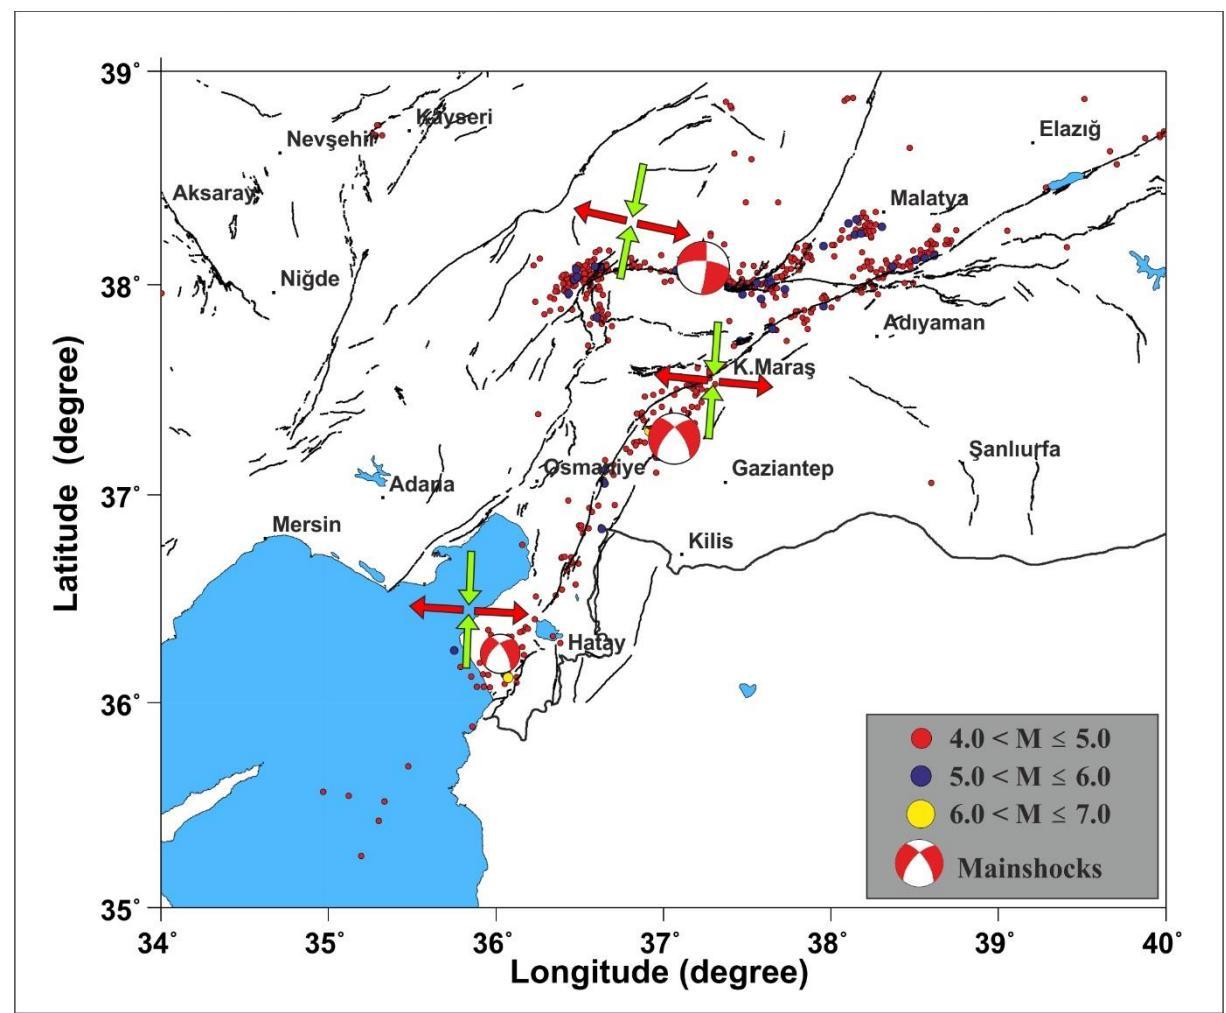
Figure 3. View of the earthquakes of 6 February 2023 (7.7 and 7.6) and 20 February 2023 (6.3) and the aftershocks that occurred with a magnitude greater than 4.0, as well as the compression-expansion directions of the earthquakes

The epicenter of the Pazarcık earthquake falls just to the SE of Türkoğlu, at the junction of the Pazarcık and Amanos segments. During this earthquake, Pazarcık-Erkenek and Amanos segments ruptured. The earthquake occurred at a depth of 10 km. A 6.7 magnitude aftershock occurred minutes after this earthquake. The epicenter of the Elbistan earthquake was located near Nurhak and broke the Çardak Fault. This earthquake also occurred at a depth of 10 km. The Elbistan earthquake occurred only 8 hours after the first earthquake. Thousands of aftershocks occurred after both earthquakes. The aftershocks were mostly on the faults that broke. The Samandağ earthquake occurred just GB of Hatay and is thought to be related to the Cyprus-Antakya Transform Fault (CAT) (Figure 3 and Table 1).

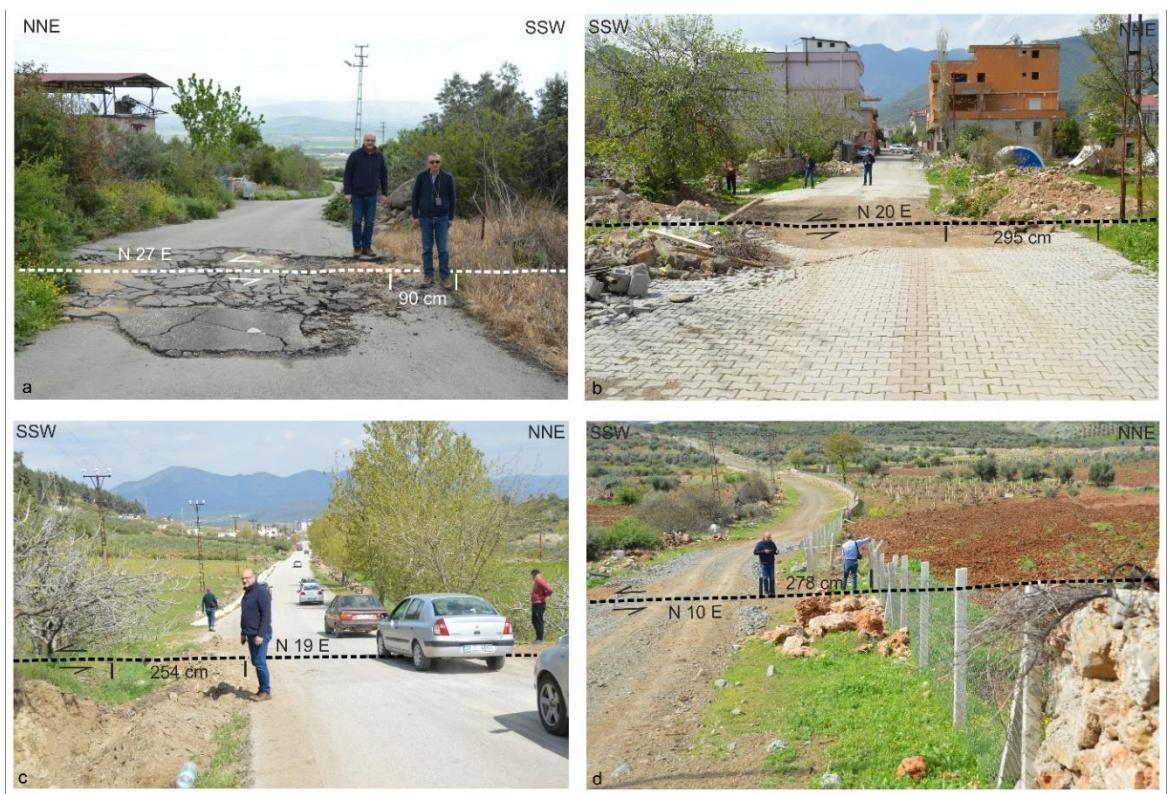
Figure 4. (a) Alibeyçağıllı (Kırıkhan, Hatay) Village Road in front of the cemetery (UTM: 37 S 0266605-4054803), **(b)** Hassa (Hatay) central cobblestone road (37 S 0278604-4075776), **(c)** Akbez (Hassa, Hatay) road (37 S 0280649-4081480), **(d)** Yeşilyurt Village (Islahiye, Gaziantep) garden wire fences (37 S 0282502-4084680)

In this study; On the Amanos and Pazarcık segments of the 06 February 2023 Pazarcık (Kahramanmaraş) Earthquake (Mw:7.7); 90 cm on the road in front of the cemetery at Alibeyçağıllı (Kırıkhan, Hatay) Village Headman's Office (Figure 4a), 295 cm on the Hassa (Hatay) central cobblestone road (Figure 5b), 254 cm on the Akbez (Hassa, Hatay) road (Figure 5c), Yeşilyurt Village (Islahiye, Gaziantep) garden fences measured 278 cm (Figure 5d). Towards the north, 167 cm on the Islahiye (Gaziantep) State Hospital Road (Figure 6a), 259 cm on the Nurdağı (Gaziantep) Aşağıolucak Village Cemetery side road (Figure 6b), 190 cm on the northern exit channel of Narlı town (Pazarcık, Kahramanmaraş) (Figure 6c) and Narlı The formation of a two-way fracture (Figure 6d) was detected at the northern exit of the town.

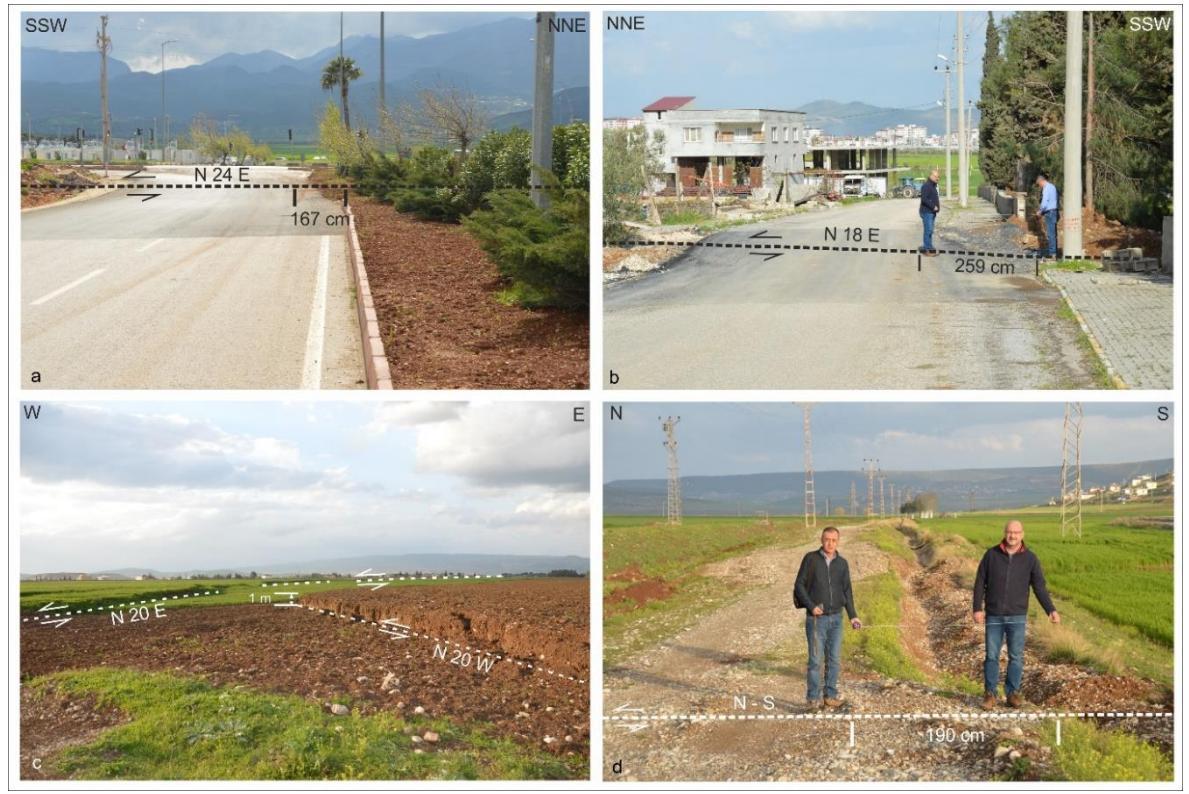
Figure 5. (a) Islahiye (Gaziantep) State Hospital Road (37 S 0289210-4102872), (b) Nurdağı (Gaziantep) Aşağıolucak Village Cemetery side road (37 S 0297055-4117046), (c) Narlı Town (Pazarcık, Kahramanmaraş) north exit channel (37 S 0336493-4141241), (d) Narlı Village northern exit three-way fracture (37 S 0336493-4141241).

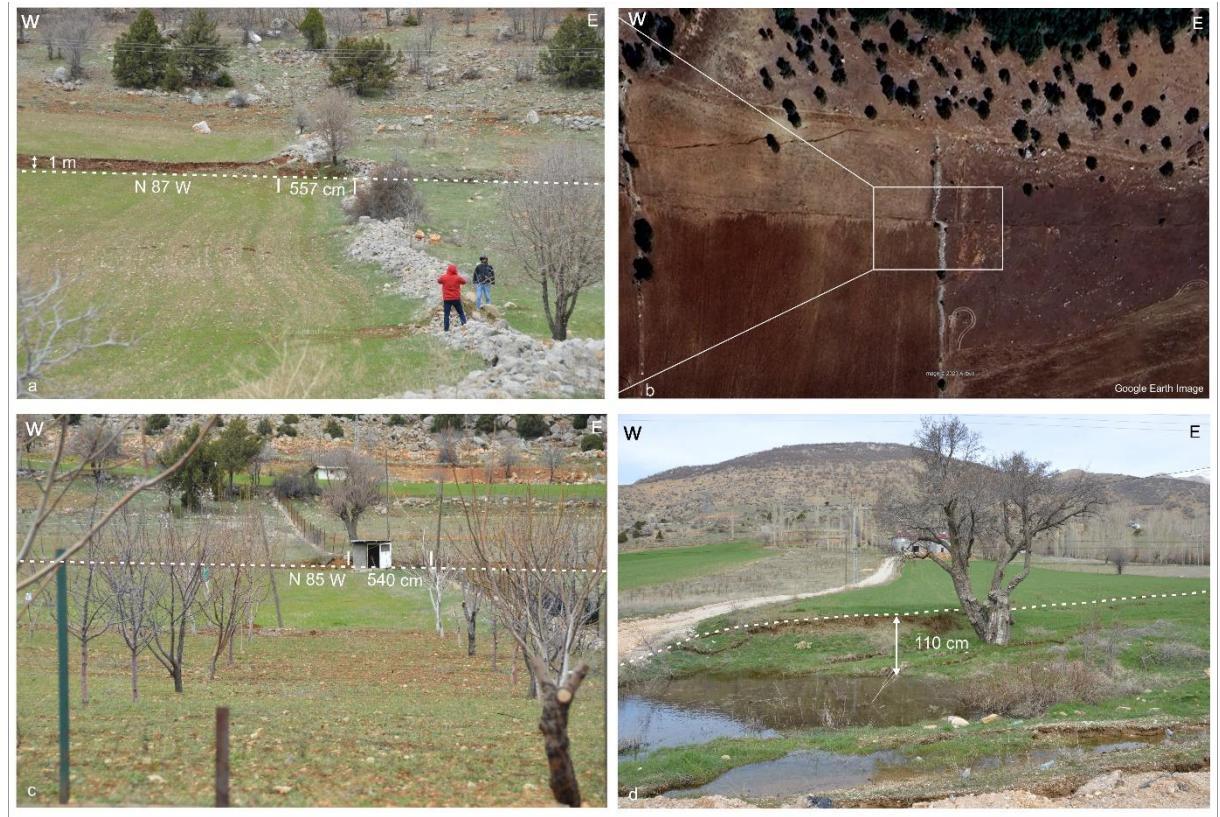
Figure 6. (a) Stone walls west of Barış Village (Nurhak, Kahramanmaraş) (37 S 0350350-4208683), (b) Google Earth Image of the left lateral slip in the masonry stone wall west of Barış Village (37 S 0350350-4208683), (c) Garden wire fence west of Barış Village (37 S 0348017-4208937) and (d) Vertical displacements along the surface fracture on the side of the main road west of Barış Village.

The surface ruptures formed by the 06 February 2023 Elbistan (Kahramanmaraş) Earthquake (Mw:7.6) started from the west of Nurhak in the east and extended to Göksun in the west. On this fault; Left lateral pulses of 557 cm (Figure 6a-b) were measured on the stone wall in the field west of Barış Village (Nurhak, Kahramanmaraş) and 540 cm (Figure 6c) on the garden wire fence west of Barış District. Additionally, vertical displacements were observed along the surface fracture on the side of the main road west of Barış Village.
